Inspection Report
Minerals Regulatory Program
May 29, 2008

| Mine Name: Hi Cal | Permit Number: M0230071 |
| Operator Name: Robert Steele | Inspection Date: March 12, 2008 |

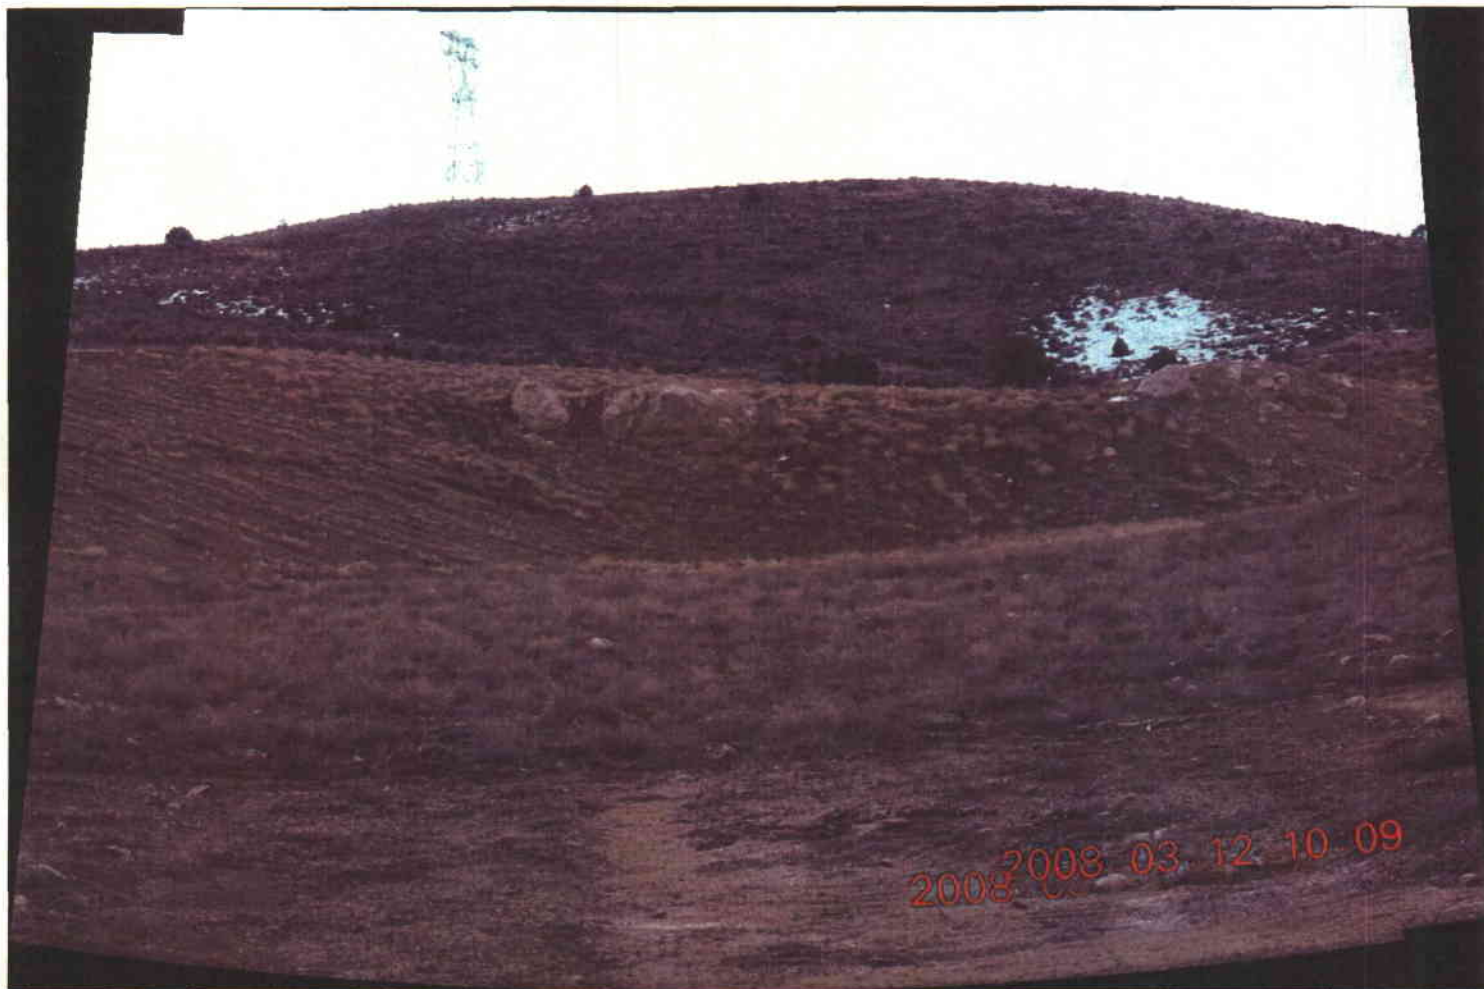
Photo taken 03-12-08

Inspection Summary: The site had been fully regraded and there was some evidence of seeding. It is important to note that this is the wrong time of year to seed and it will be the reason to keep extra bond money for reseeding if it needs to be redone.

Conclusions and Recommendations: The Division recommends that the operator keeps his seed tags and present them to the Division as there was an approved seed mix for the site. Also Mr. Steele should provide evidence that the site was seeded. OGM to continue annual inspections and monitor the site when in the area. Revegetation is non-evident (only Russian thistle). A fall inspection might show some vegetation success.
